**സെന്റർ ഫോർ വാട്ടർ റിസോഴ്സ് ഡെവലപ്മെന്റ്
ആൻഡ് മാനേജ്മെന്റ് റിപ്പോർട്ട്**

Investigation on the Sudden Depletion of River Flows and Declining of Groundwater Table Subsequent to 2018 Floods in Kerala

**RELEVANCE OF GAYATHRI SUB WATERSHED PLAN
IN
MITIGATION OF NATURAL CALAMITIES**

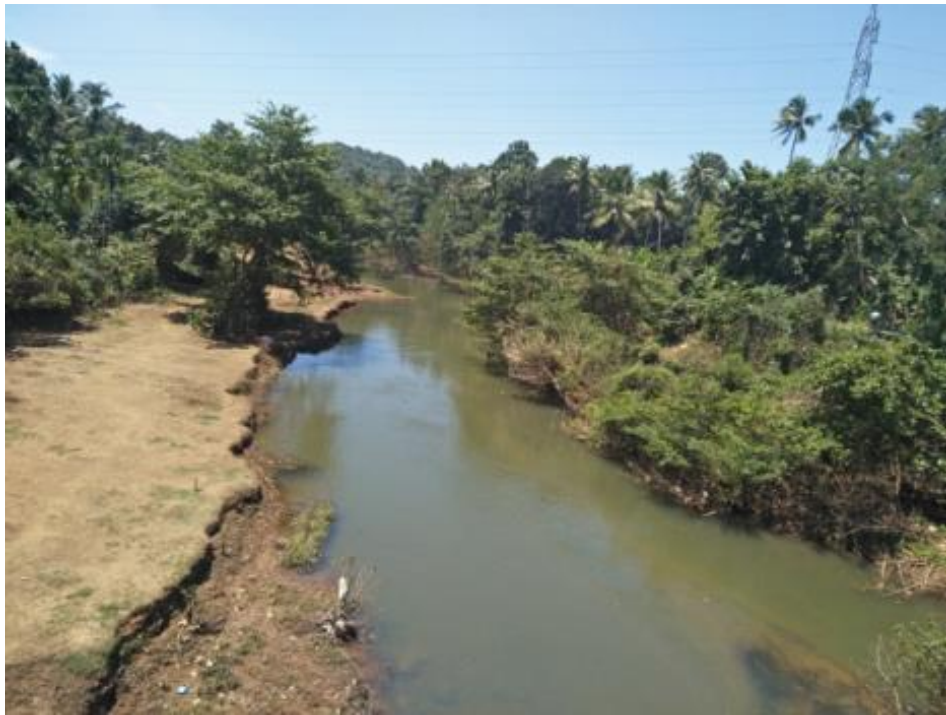
Plate 1. Punoorpuzha at Pandaraparamba (river bed erosion)

On 8th September 2018, it has been observed that the water level in Punoorpuzha river at Pandaraparamba (Kozhikode district) has shown a fall of 1.5m compared to the water level during September 2017. Also, the water level in dug wells located about 55m away from the river at Pandaraparamba shows a drawdown of 1.0m compared to the water level during September 2017. The field investigation revealed that about 1.1m thick of the sandy river bed of Punoorpuzha (more than half of the river width) at Pandaraparamba (Plate 1) has been eroded during the flood period.

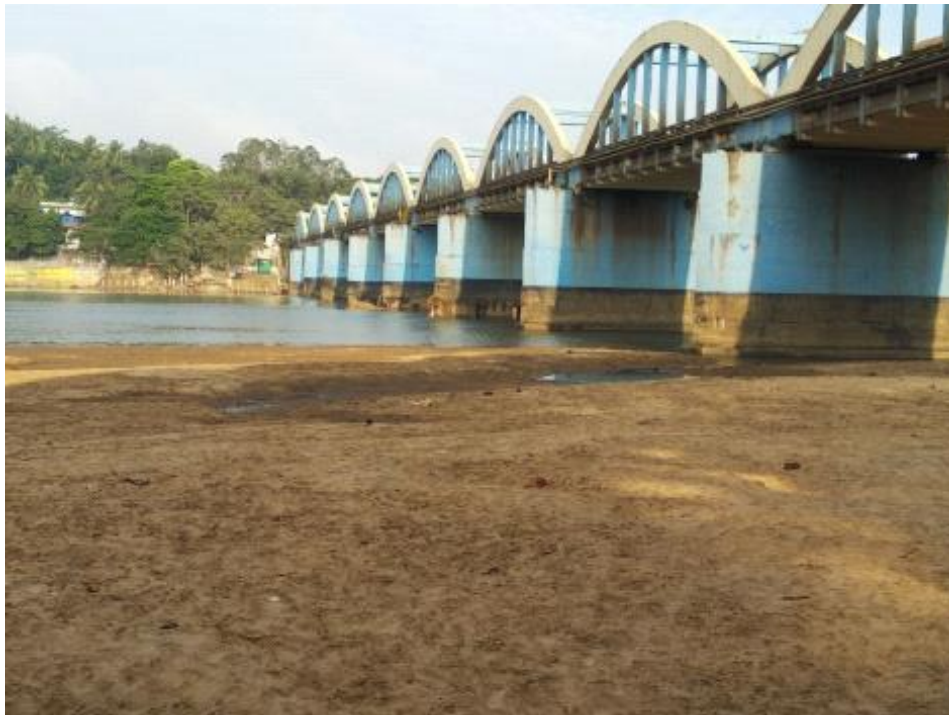
Plate 2. Bharathapuzha river at Kuttippuram Bridge

On 12th September 2018, it has been observed that the water level in Bharathapuzha river at Kuttippuram (Plate 2) has shown a fall of 1.0 m compared to the water level during September 2017. On 18th September 2018, Manimala river at Vallamkulam bridge (Plate 3) has shown a fall of 1.2 m compared to the water level during September 2017. On 19th September 2018, Meenachil river at Pallikkunnu (Plate 4) has shown a fall of 1.2 m compared to the water level during September 2017. On 20th September 2018, Kariangode river at Kayyur (Plate 5) has shown a fall of 1.3 m compared to the water level during September 2017. River bed erosion is one of the major causes for the depletion of water flows in these rivers.

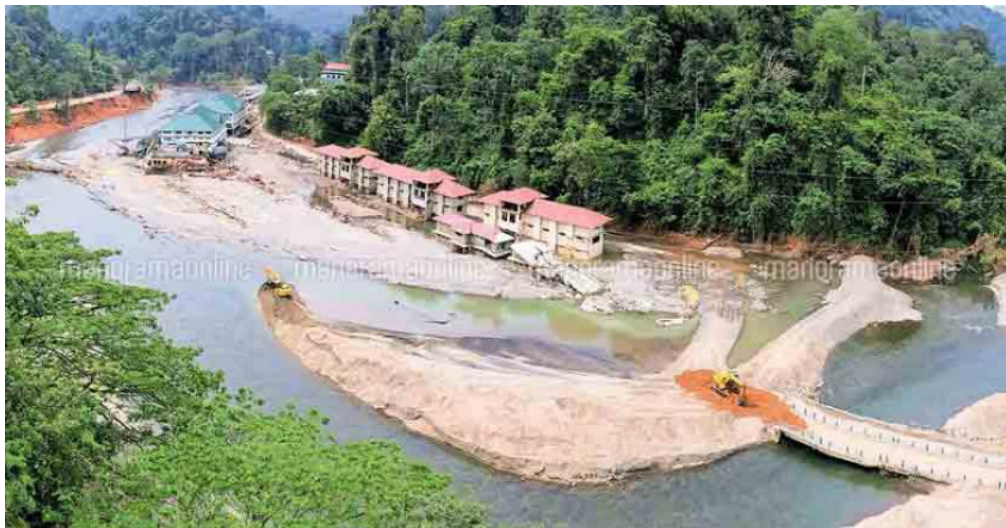
Plate 6. Pampa river at Thriveni (deposition of debris/sand/clay)

Deposition of debris and mud in river beds: It is reported that more than 200 landslides has been occurred in Kerala during the 2018 flood period. The debris, sand, mud/ clays displaced due to landslides finally reach to the downstream rivers and will deposit in river beds and banks. The deposition of debris, mud/ clays in river bed may act as an impermeable layer in river beds and restrict the groundwater flow in river beds (both groundwater inflow and out flow).

The flood has induced about 4 m thick deposition of debris, sand, mud/ clays in Pampa river bed at Thriveni (Plate 6). After the flood, sand banks have been created along the Periyar river at Kothamangalam, Kalady and Perumbavoor. On 21st September 2018, it has been observed that the water level in Pampa river at Kozhancheri (Plate 7) has shown a fall of 1.2 m compared to the water level during September 2017. Also, the water level in dug wells located about 50m from Pampa at Kozhancheri shows a drop of 1.5 m compared to the water level during September 2017. The water level in Pampa river at Ranni has shown a fall of 1.2 m compared to the water level during September 2017. The water level in dug wells located about 60m from Pampa at Ranni (Plate 8) shows a fall of 1.6 m compared to the water level during September 2017. On 21st September 2018, it has been observed that the water level in Manimala river at Mallappally (Plate 9) has shown a fall of 0.6 m compared to the water level during September 2017.

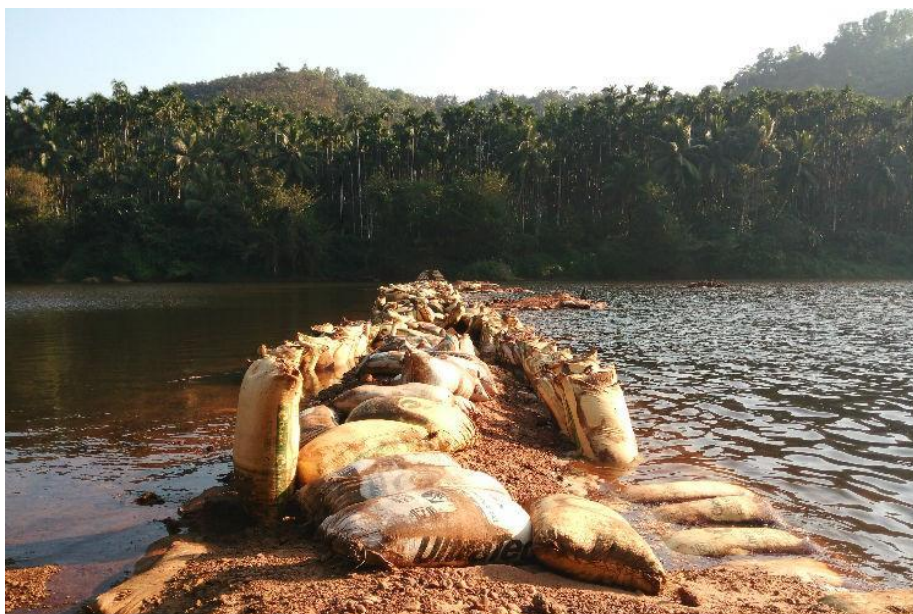
Plate 10. Chandragiri river, Kasargode (Temporary check dam before flood)

Removal of Flow Obstructions: Many temporary check dams across the streams/ rivers and mud banks, etc has been washed out during the floods (Plate 10). The removal of obstructions in streams/ rivers has led to the draining out of river water to the estuarine very fast.

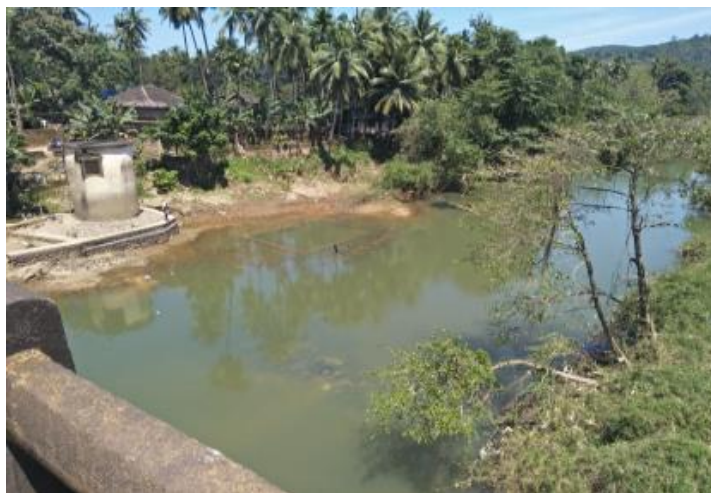
Plate 11. Cherupuzha at Chethukadavu

On 7th September 2018, it has been observed that the water level in Chaliyar river at Oorkkadavu has a fall of 1.5m compared to the water level during September 2017. Water level in Cherupuzha (a tributary of Chaliyar) at Chethukadavu (Plate 11) has shown a fall of 1.0m compared to the water level during September 2017. The water level in open wells located about 45m from Cherupuzha river shown a drawdown of 1.3 m compared to the water level during September 2017. After the closure of thirteen shutters of Kavanakkallu Regulator (out of fifteen shutters) on 8th September 2018, the water level in Chaliyar river at Oorkkadavu on 9th September 2018 showed a rise of 1.5m in the upstream of Kavanakkallu Regulator (Plate 12) and water level in Cherupuzha (Plate 13) has shown a rise of 0.5m. Also, the water level in open wells located about 45m from Cherupuzha river shown a rise of 0.4 m.

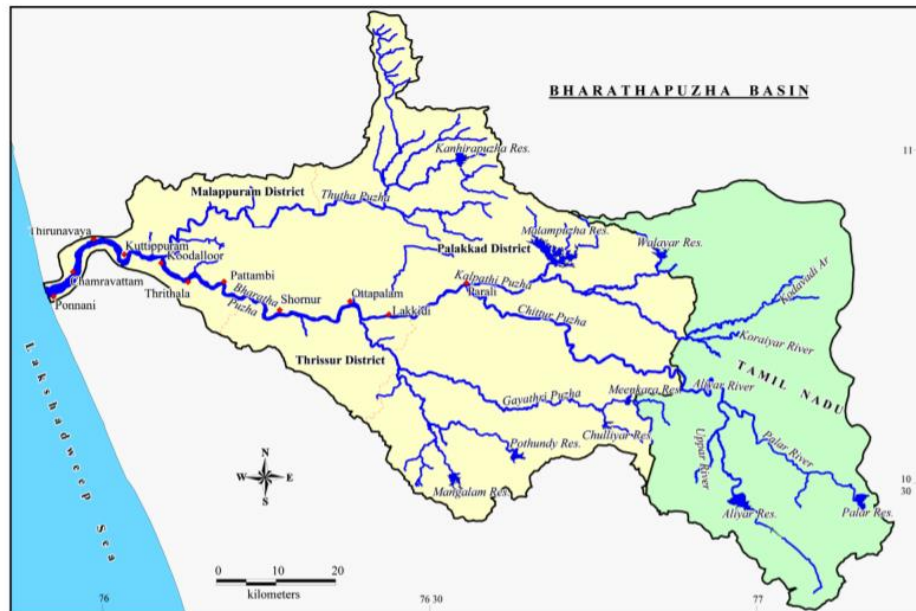
Fig.14 Drainage map of Bharathapuzha showing Reservoirs in the Upper Catchments

Dams across the river course: The dams in Kerala are constructed for conserving the monsoon flows (otherwise discharged to the Sea) and use for power generation, irrigation and domestic purpose. Dams across the rivers, several of them along the course of the same river (Bharathapuzha-11nos, Periyar-17nos, Pampa-2nos, etc) may often adversely affect the flow pattern in the downstream of the dams (because whatever flow in the upper catchment, will be conserved in the reservoirs). Hence, river flows in the downstream of dams are relatively very low especially during the non-rainy days. The drainage map showing a series of dams in upper catchments of Periyar and Muvattupuzha & Bharathapuzha are shown in Figures 13 & 14. The river flow in Bharathapuzha during the second week of September 2018 is shown in Plate 14.

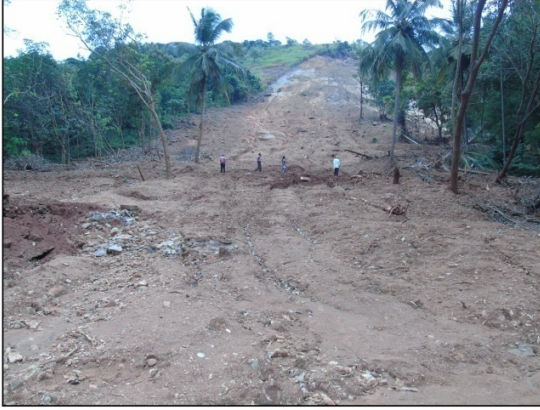
20B39aj - ഉരുൾപൊട്ടൽ

ആതനാട് മലയിൽ അലുവാശ്ശേരി ചേരുകാട് ഭാഗം - നെന്മാറ പഞ്ചായത്ത്

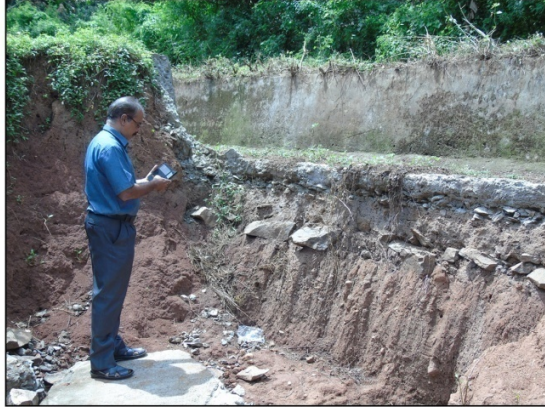
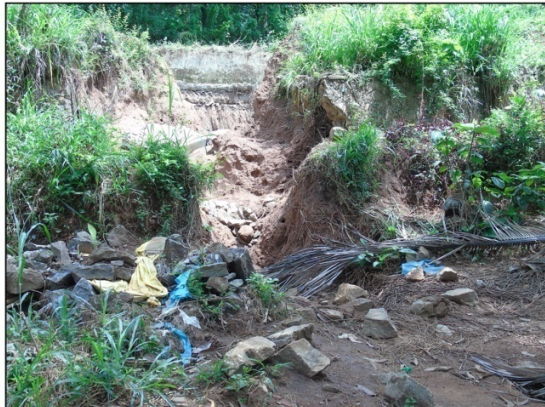
20B39ao - കനാൽ ബണ്ട് പൊട്ടൽ

അയിലിമുടിച്ച് മലയുടെ അടിവാരത്തുകൂടി പോത്തുണ്ടി ബ്രാഞ്ച് കനാൽ കടന്നു പോകുന്ന കുറുമ്പൂർ എന്ന പ്രദേശം (അയിലൂർ പഞ്ചായത്ത്)

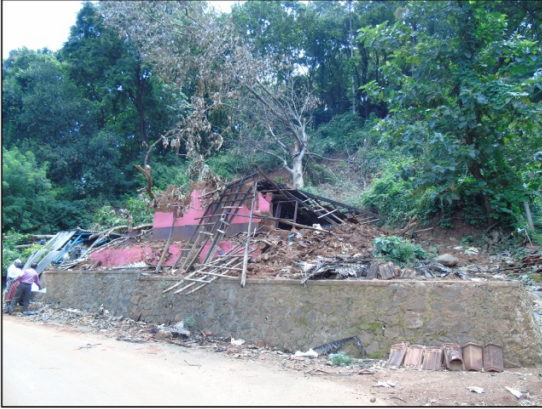
20B39a0 - മണ്ണിടിച്ചിൽ
അയിലൂർ പഞ്ചായത്ത് തെക്കേ കുളമ്പ് ഭാഗത്ത്
മണ്ണിടിഞ്ഞ് പൂർണ്ണമായും തകർന്ന വീട്

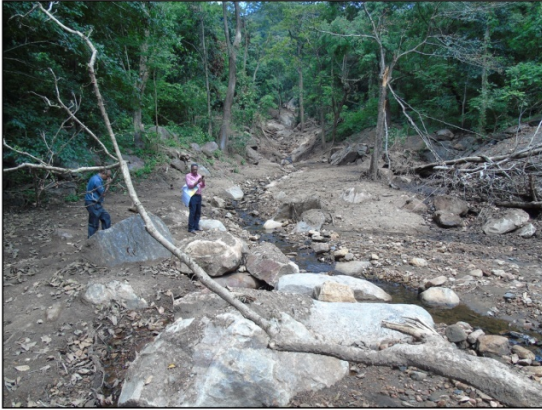
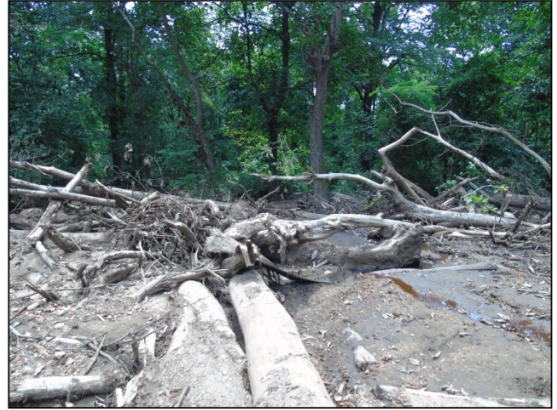
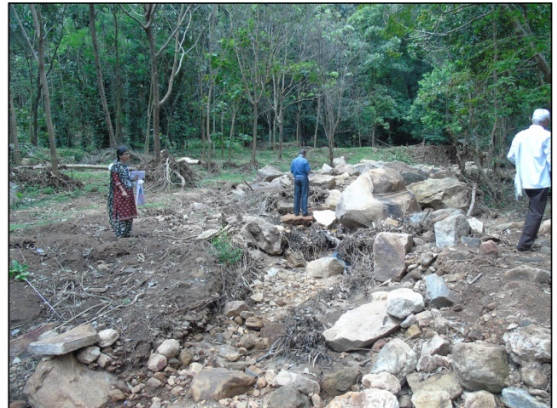
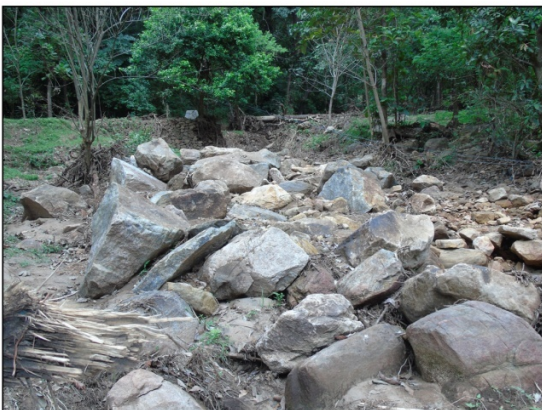
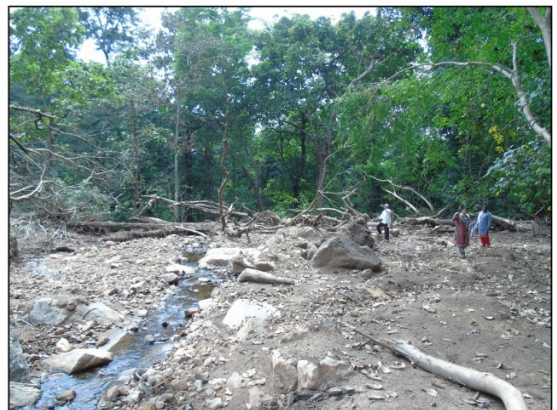
20B39ar - ഉരുൾപൊട്ടൽ

നെല്ലിയാമ്പതി പഞ്ചായത്തിലെ സംരക്ഷിത വനമേഖല (പൂങ്ങോട് മല) യിൽ നിന്നാരംഭിക്കുന്ന നിരങ്ങൻപാറ ഫോറസ്റ്റ് ചാലിൽ (അയിലൂർ പഞ്ചായത്ത്) ഉണ്ടായ ഉരുൾപൊട്ടൽ

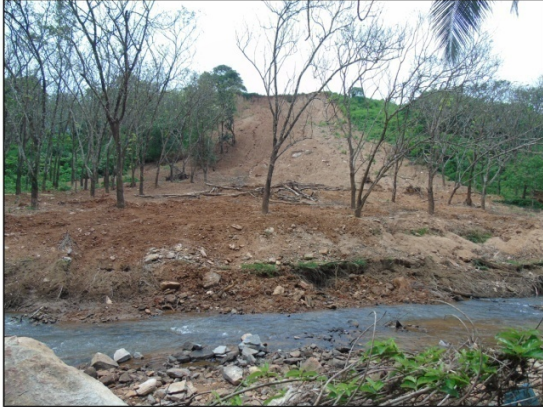
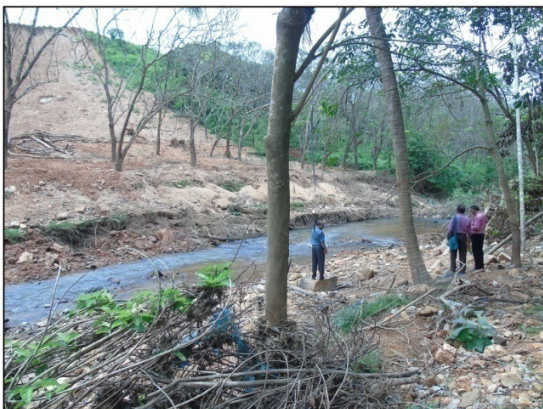
20B39ap - മണ്ണിടിച്ചിൽ, പുഴ ഗതിമാറി ഒഴുകൽ

വീഴ്ലി പുഴയുടെ ഇടതുകരയിൽ വണ്ടാഴി പഞ്ചായത്തിന്റെ ഭാഗമായി നിലകൊള്ളുന്ന 20B39au നീർത്തടത്തിന്റെ നീർമറിരേഖയിൽ പ്രവർത്തിക്കുന്ന ക്വാറി വേസ്റ്റ് കുന്ന ഇടിഞ്ഞ് വീഴ്ലിപുഴയിലേക്ക് വീഴുകയും തദ്ദേശ വീഴ്ലിപുഴ കരകവിഞ്ഞ് ഗതിമാറി വലതുകരയിലുള്ള 20B39ap ചെറുനീർത്തടത്തിൽ അയിലൂർ പഞ്ചായത്തിൽ ഉൾപ്പെട്ട 3 വീടുകൾ തകരുകയും ചെയ്തു.

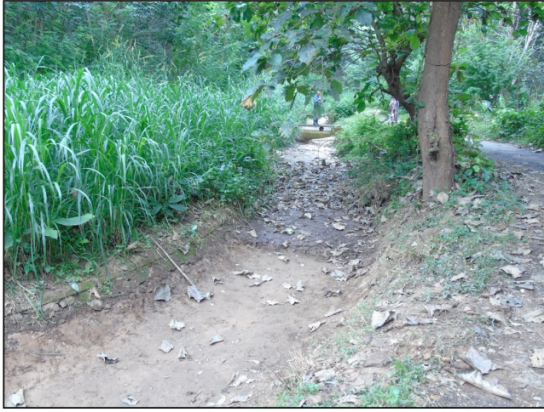
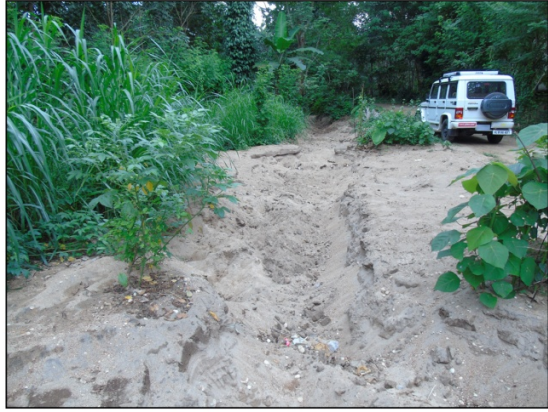
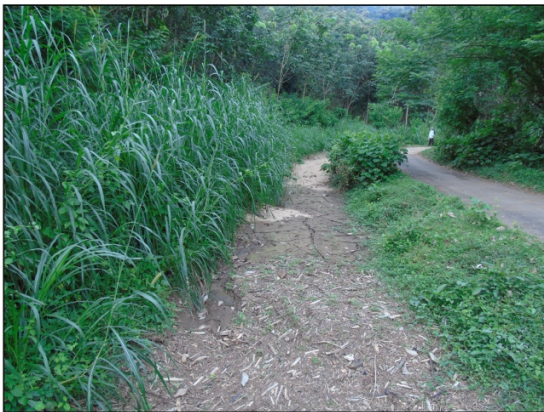
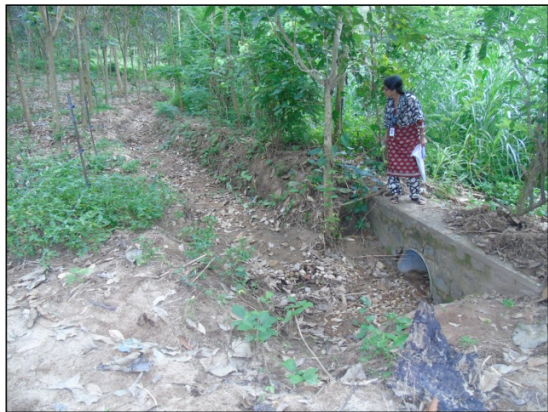
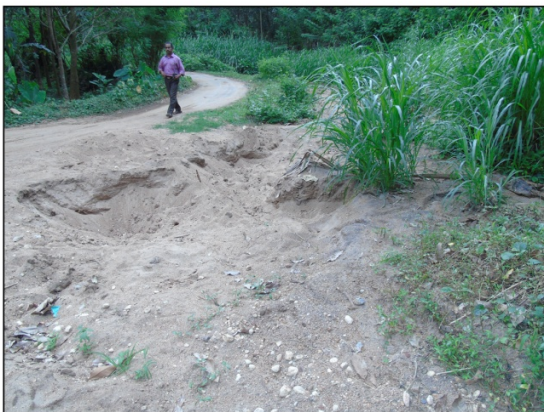
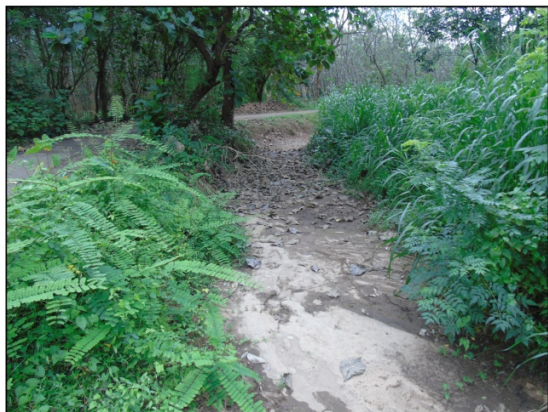
20B39as - ഉരുൾപൊട്ടൽ

നെല്ലിയാമ്പതി പഞ്ചായത്ത് സംരക്ഷിത വനമേഖലയിൽ നിന്നാരംഭിക്കുന്ന പുഞ്ചേരി വണ്ടികടവ് ചാലിൽ ഉരുൾപൊട്ടി പോത്തുണ്ടി കൽച്ചാടി ബ്രാഞ്ച് കനാലിൽ (അയിലൂർ പഞ്ചായത്ത്) 2 കി.മീറ്റർ ദൂരം പൊടി മണ്ണും, മണലും അടിഞ്ഞ് അകാഡക്ട് ഉൾപ്പെടെയുള്ള ഭാഗം പൂർണ്ണമായും മൂടപ്പെട്ടു.
