ആക്കളം ടൂറിസ്റ്റ് വില്ലേജിലെ ഗ്ലാസ് ബ്രിഡ്ജ്

REPORT ON SUB SOIL EXPLORATION FOR PROPOSED BRIDGE FOR AKKULAM CHILDREN'S PARK AT AKKULAM

**THE TECHNICAL INVESTIGATION OF
THE GLASS BRIDGE IN AKKULAM TOURIST VILLAGE,
AKKULAM, THIRUVANANTHAPURAM**

AKKULAM TOURIST VILLAGE TYPICAL FLOOR GLASS SUGGESTION DRAWING

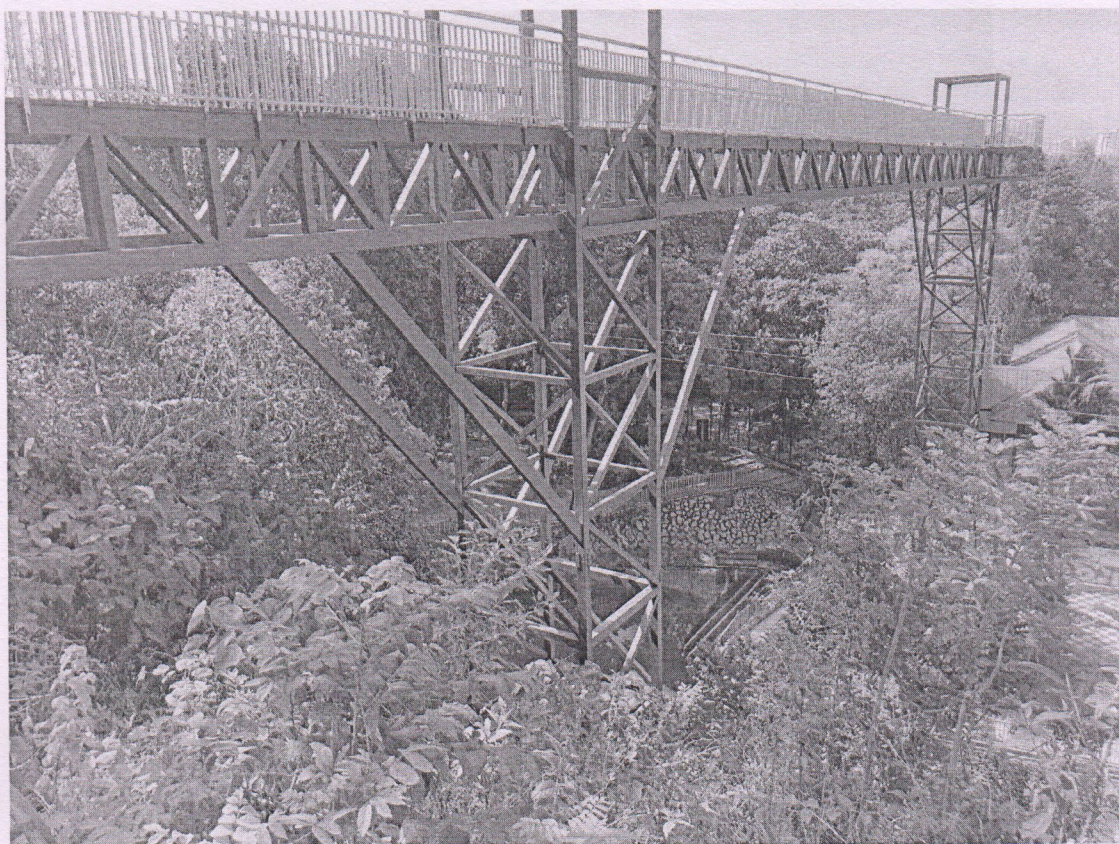
Plate 1. General view of glass bridge.

The total length of the bridge deck is about 54m. The bridge structure is made of steel tubular sections and supported on three steel lattice towers. The height of the tower at the near end is about 6m and the height of other two towers is about 24m. As per the structural drawings, the towers are supported on pile foundation. The width of the bridge deck is 2.40m. The plate 1 gives a general view of the glass bridge.
